# Characterization and Weathering of the Building Materials of Sanctuaries in the Archaeological Site of Dion, Greece

**Abstract** The sanctuaries of Demeter and Asklepios are part of the Dion archaeological site that sits among the eastern foothills of Mount Olympus. The main building materials are limestones and conglomerates. Sandstones, marbles, and ceramic plinths were also used. The materials consist mainly of calcite and/or dolomite, whereas the deteriorated surfaces contain also secondary and recrystallized calcite and dolomite, gypsum, various inorganic compounds, fluoroapatite, microorganisms and other organic compounds. Cracks and holes were observed in various parts of the stones. The influence of specific weathering agents and factors to the behavior of the materials was examined. The particular environmental conditions in Dion combine increased moisture and rain fall, insolation and great temperature differences, abundance of intensive surface and underground water bodies in the surrounding area, an area full of plants and trees, therefore, they can cause extensive chemical, biological and mechanical decay of the monuments. The following physical characteristics of t

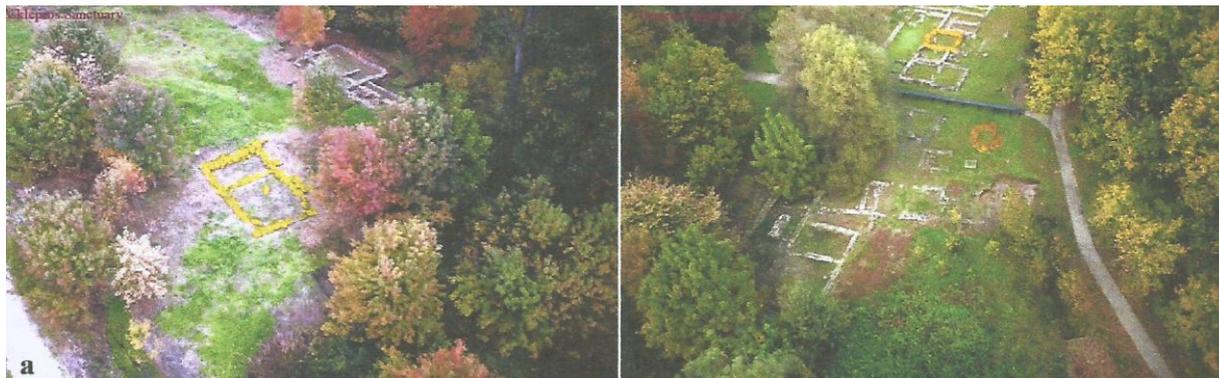
**Figure 1** General view of the sanctuaries of a) Asklepios, b) Demeter.

The aim of the present work is the study of the effect of the environmental factors and the deterioration problems of stone monuments of Demeter and Asklepios sanctuaries in Dion archaeological site (Figure 1), one of the most important religious centers of ancient Greeks in central Macedonia. In earlier works<sup>[17-20]</sup> it was found that the main building materials of the monuments are limestones and conglomerates. Sandstones, marbles and ceramic plinths were also used. The materials consist mainly of calcite and/or dolomite. The surfaces of the building materials are partially covered by the weathering products of the primary minerals such as secondary carbonate (calcite-dolomite) precipitated from water solutions, recrystallized calcite and dolomite and in some cases gypsum. The presence of crusts of various

A series of samples of the various building materials were collected from different locations of both monuments, Asklepios and Demeter. The accurate sampling sites were previously mentioned and presented<sup>[17]</sup>. The in situ measurements were focused in two monuments, Asklepios Temple, Altar in Demeter sanctuary (Figure 1).

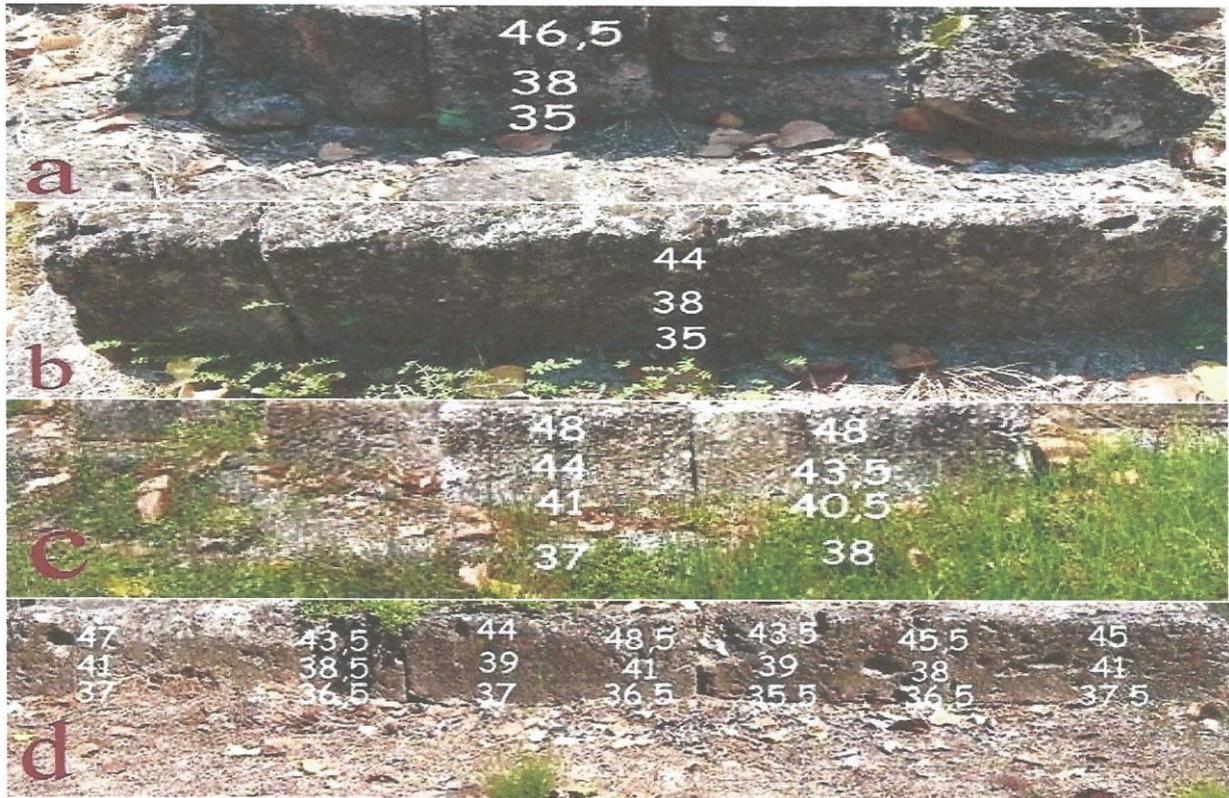
Figure 7 IR thermometer measurements, sunny conditions, Demeter sanctuary, Altar, a) north side, b) east side, c) south side, d) west side.

The results of the IR thermometer in situ measurements are shown in Figures 6, 7 (sunny conditions) and Figures 8, 9 (wet conditions).

Since a moist porous material presents emittance variations, moisture detection in porous stones by means of IR thermometer measurements is feasible. IR thermometry monitors the water movement in porous materials and detects its impact by recording temperature variations on the stones' surfaces. The presence of moisture (lower temperatures) that arises as a result of the capillary movement of water causes deterioration of the building material. In such cases, the optical properties are altered, the density, specific heat capacity and thermal conductivity are also affected and so any temperature changes are much slower in a moist area, as the energy required to raise the temperature of a moist area would be much greater than an area that is unaffected by water. In all cases of IR thermometer in situ measurements, the

recorded temperatures on the side surfaces of the walls increase with the distance from the ground. The temperature differences depend mainly on the environmental conditions (sunny or wet), also on the kind of the material and the orientation of the wall, being greater in sunny and smaller in wet conditions. The IR thermometer measurements correlated with the water and capillary absorption and desorption results (Table 2) and also the permanent intensive presence of surface and underground waters indicate that the main deteriorating factor of the materials is the moisture penetration due to capillary action. In sunny conditions, moisture penetrates into the materials only by capillary absorption (greater temperature differences, Figures 6, 7), while in wet conditions rain water and environmental humidity contribute also to the total moisture absorption (smaller temperature differences, Figures 8, 9).

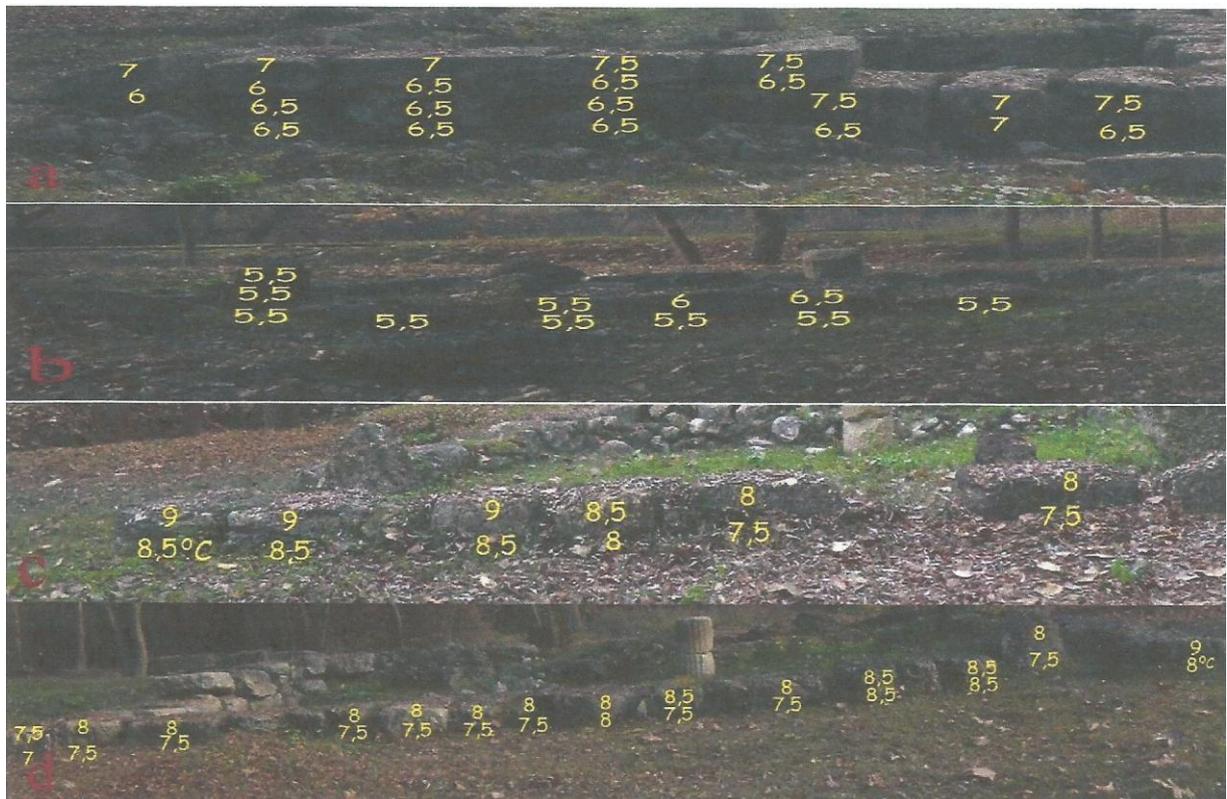
Figure 8 IR thermometer measurements, wet conditions, Asklepios temple, a) north side, b) east side, c) south side, d) west side
